MISCELLANEOUS PAPER GL-92-11

STABILITY OF OPEN-GRADED BASES UNDER WHEEL LOADS USING A MODEL TESTING APPROACH

Geotechnical Laboratory

May 1992

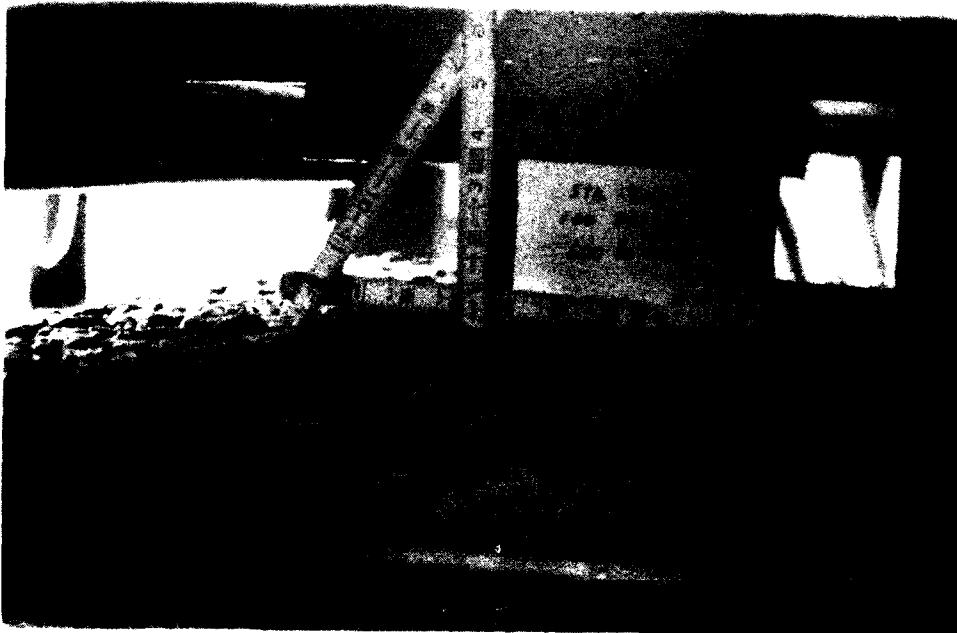
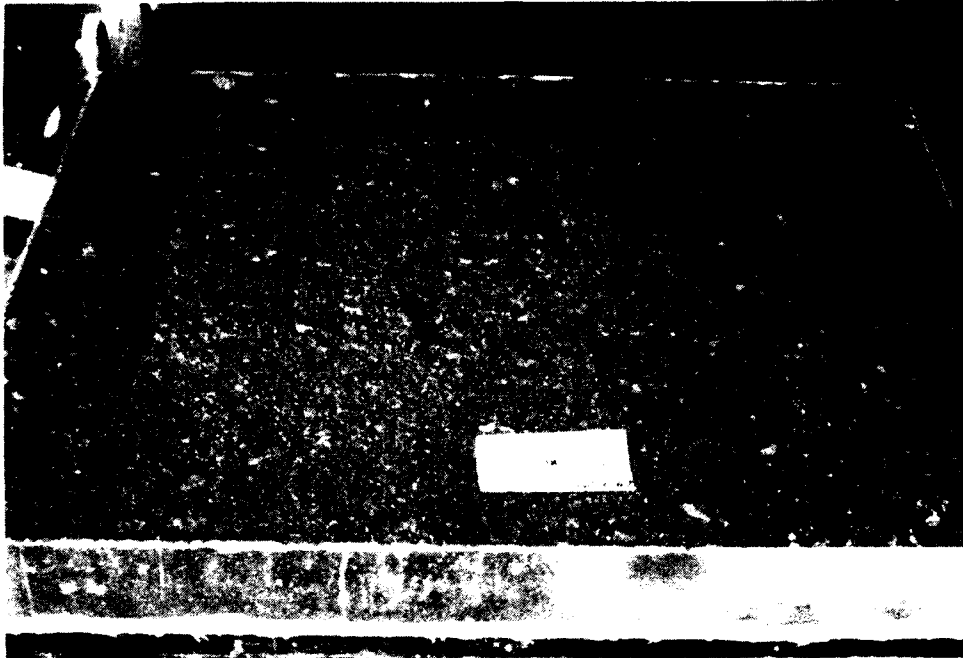
Photo 23. Standard crushed gradation during testing

Photo 24. Standard crushed gradation during testing

Photo 25. CS-I crushed gradation before traffic

Photo 26. CS-I crushed gradation during testing

Photo 27. CS-II crushed gradation before traffic

Photo 28. CS-II crushed gradation during testing

Photo 29. CS-III crushed gradation before traffic

Photo 30. CS-III crushed gradation during testing

Photo 31. CS-IV crushed gradation before traffic

Photo 32. CS-IV crushed gradation during testing

Photo 33. CS-V crushed gradation before traffic

Photo 34. CS-V crushed gradation during testing

Photo 35. CS-VI crushed gradation before traffic

- f. Finally, to obtain the relative permeability of the different gradations, a simple test was performed directly on top of the base. The test consisted of measuring the time it required for a 2-1/8-in.-diam column of water to fall 5 in. while draining into the base course. Photos 21 and 22 show the PVC pipe utilized for this purpose. It consisted of a pipe with a plastic base and a hole in its side connected to a water hose. Clay was used to seal the contact between the plastic base and the surface of the base course so that the water was forced to move downward through the base. A weight was placed on top of the pipe to keep it from moving during the test. After the pipe was filled close to its top, the time required for the water to fall freely 5 in. was recorded using a stop watch. The test was performed three times and the average used as the measurement of the permeability. Photos 23-37 show the texture of each of the gradations tested before and during traffic.

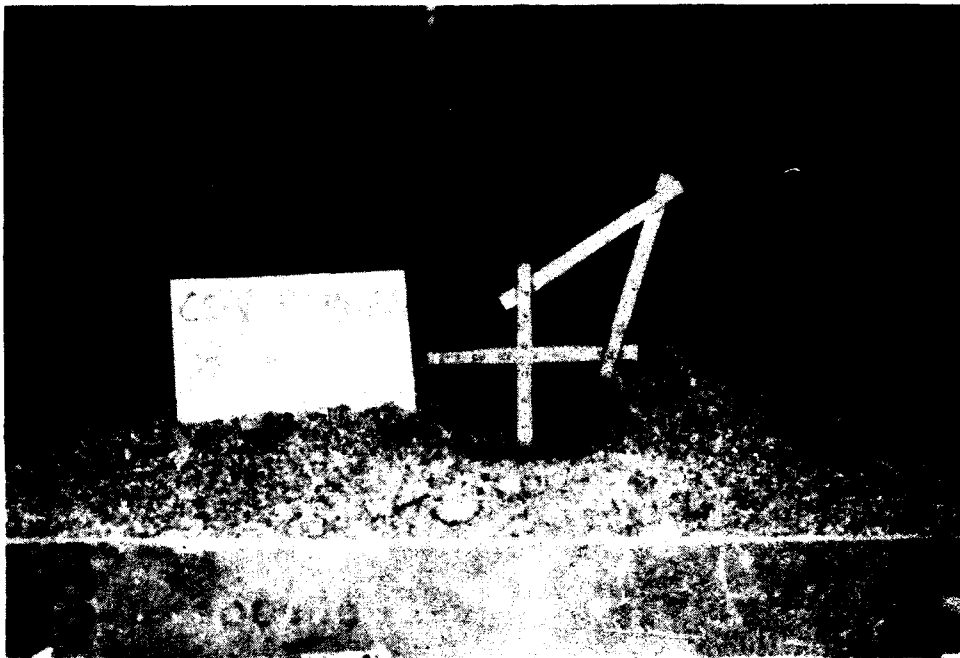
Photo 36. CS-V rounded gradation before traffic

Photo 37. CS-V rounded gradation after 8 passes

13. The results of two tests performed on the CE standard and the CS-V gradations, utilizing in this case rounded aggregates instead of crushed stone, are presented in Table 2 and Figure 6. The rut depths of the standard gradations indicate that its stability was greatly reduced when compared with the standard crushed stone gradation. In this case the rut depth increased up to eleven-sixteenths inch compared with only one-fourth inch for the crushed stone. In fact, the resulting rut depths were greater than all of the more open crushed graded bases tested, except the CS-III. This is an indication of the poor stability that can occur in the field during the placement of bases with rounded aggregates. This fact was confirmed with the results from the CS-V gradation. In this case, the deformations became so large that the test had to be stopped after only a few passes because the equipment was dragging on top of the base. After only 8 passes the rut depth increased to 2-11/16 in. As these tests demonstrated, rounded materials do not provide
